# WARREN COMMONS

New for this year is our first stormwater management site for the Conservation Tour. The Warren Commons site was very controversial with local residents due to the already problematic lower Jackson Run watershed.

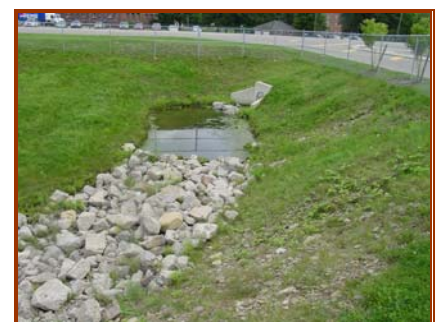
The completed site has many post-construction best management practices (BMP) that you see and some that you would never know are there. The most obvious BMP is the large detention basin located directly behind Walmart. Stormwater that reaches this basin's outlet eventually leaves the site via an underground 36" storm sewer that goes under Route 62 across the State Hospital property and discharges into the Conewango Creek. This basin basically serves the site from the main entrance road to the north. One unique characteristic of the basin is that it contains a water quality forebay that actually serves as a basin within another basin. The forebay basically adds another filter to the system.

*Picture showing forebay*

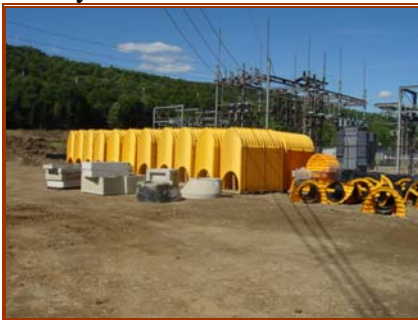
Working south from the large basin also directly behind Walmart is a Cultec underground infiltration system that consists of plastic underground structures that interlock and provide an area

for stormwater to infiltrate back into the groundwater rather than running off directly into the basin. The structures are bedded in gravel and the soil in each location was specifically tested to make sure it was suitable for infiltration. The current regulations require the 2-year 24/hour storm to be infiltrated or recycled onsite.

*Stacked Cultec infiltration chambers*

This system allows the first part of large storms to go into the underground chambers and slowly infiltrate. Once the void space within these chambers is taken up the water passes through an overflow pipe which leads to the large basin to the north. Also behind the Walmart building are the truck unloading areas. The drains that lead from this area have an emergency shut-off valve that can be turned off to prevent a chemical spill from discharging to the detention basin.

Moving further south beside the existing power substation there are two more underground infiltration areas that use the same Cultec structures as the ones behind Walmart. These catch most of the Walmart customer parking lot runoff. Once these are full the water passes through an overflow and ends up in the large detention basin to the north.

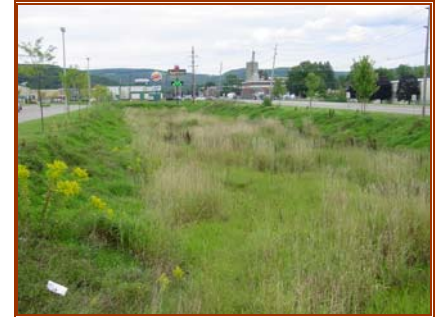
Located directly in front of Lowes between the end of the parking and Route 62 is an infiltration basin. Basically this is an aboveground system similar to the Cultec systems that allow the stormwater to infiltrate as much as possible before being routed to a detention basin. The infiltration basin has a drainage system beneath it that aids in infiltrating the water back into the ground. It consists of a series of 4" pipes that are bedded in washed gravel that are buried in the existing soil that showed suitable infiltration rates following onsite specific tests. The infiltration basin will hold around 3' of water before it will flow out through an

overflow outlet that allows the water to travel to a basin that is located along Jackson Run Road and then discharge to the stream. The site was visited after the large storm event in August and no water was seen leaving the infiltration basin.

*Picture showing infiltration basin*

And finally the last post-construction stormwater BMP is the small basin located directly beside Lowes along Jackson Run. This basin serves as the overflow for the infiltration basin in front of Lowes and also the overflow for the wetland area that is located behind Lowes. This basin has two 30" pipes that discharge to Jackson Run. This basin is relatively small because of the large capacity of the infiltration basin before it enters the drainage system.
