# AGGRAVATION ACRES

Rich and Vicki Gilkinson operate Aggravation Acres, a 60 cow dairy on approximately 60 acres of pasture and 100 acres of cropland in Farmington Township.

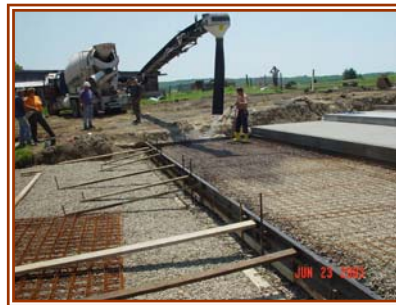
Concrete stairs during construction.

Because this is a dairy operation, the animals must travel between the barn and the pasture several times a day. Heavily used travel lanes are susceptible to erosion and may cause foot problems in the animals when the lanes are wet and muddy. A solution to the problem is to stabilize the travel lane with geotextile fabric and gravel. The Gilkinsons completed construction of a 1085 foot laneway in 2007 as part of the federal Environmental Quality Incentives Program (EQIP). The section of the laneway closest to the barn was completed several years ago under another conservation program, the Conewango Agricultural Stewardship Program. This section of the laneway consists of concrete

stairs that allow for easier travel up an incline behind the barn. The new gravel laneway starts at the edge of the concrete and extends to the back of the pasture.

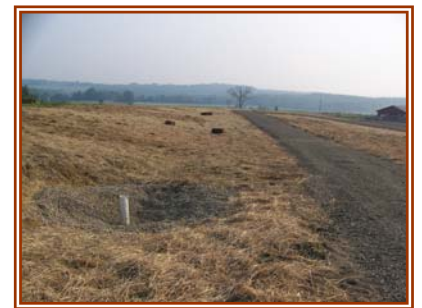
Stabilized laneway, basins, and waterway just after construction.

To address this problem, a series of basins and outlets were constructed in conjunction with a grassed waterway. These practices intercept the drainage water and transfer it to a stable outlet. This eliminates flooding problems in the barnyard, and keeps the clean water clean.

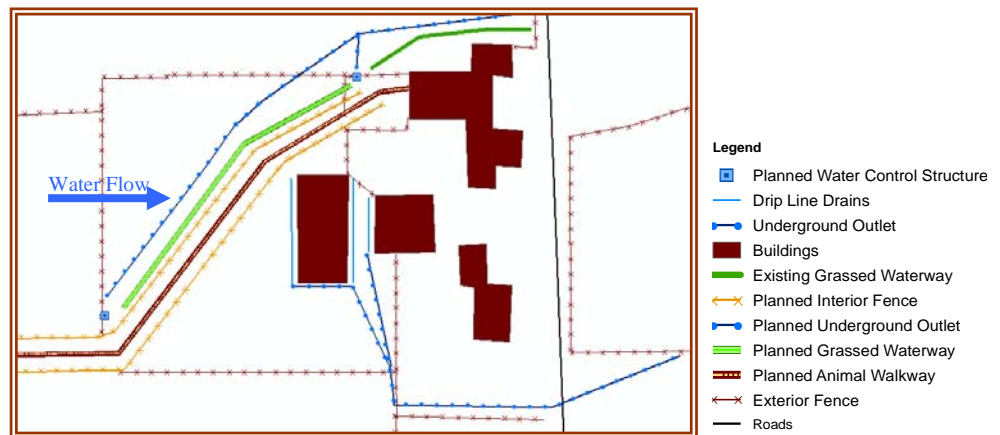
Plan view of the storm water management practices installed at the farm.

As part of EQIP, the Gilkinsons also completed several water control practices. The hillside behind the barn provided significant drainage during heavy rainfall events. Because the barn sits at the bottom of the slope, this water

ended up in and around the barn.

A new barn was recently built at the farm and the Gilkinsons, realizing the importance of barnyard conservation, installed drip drain roof runoff controls at their own expense. These drip drains collect clean roof water and transfer it to a stable outlet.
